**Flood Control Project Maintenance
Levee Inspections**

2018 Channel Summary Report

Adin Community Service District

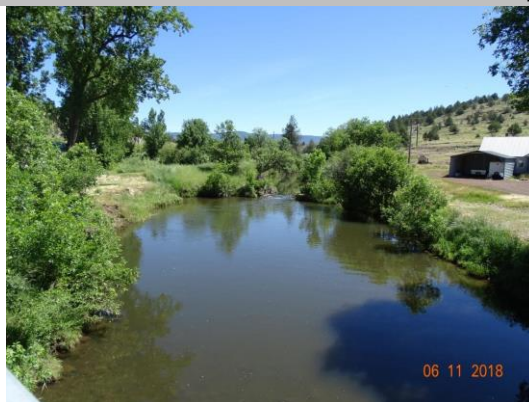
Photo 1 of 1 : CH_2018_NA0030_1_1_20180618_00007.jpg

Rating **	A	Issue No.	1	GPS Lat/Long
Issue Type +	Ma	Location *		41.197770 °
Category	Rivers, Channels & Designated Flood			-120.944100 °
Item	Vegetation & Obstructions			
DWR ID	DWR_NA0030_1_c_2012_1			
Action/Comments				
Inspector Comments: The channel is clear of vegetation & obstructions.

View from Main Street (Highway 299) towards the gauging station.

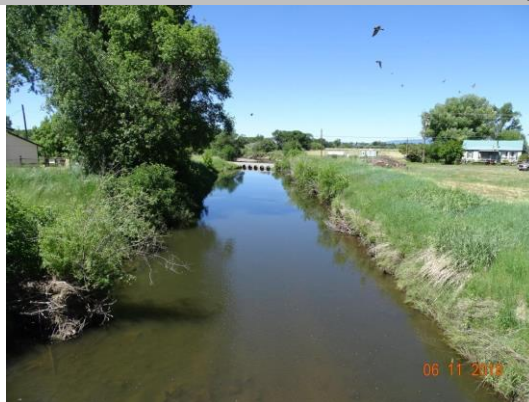
Photo 1 of 1 : CH_2018_NA0030_1_6_20180618_00008.jpg

Inspector Comments: The channel is clear of vegetation & obstructions.

View from Main Street (Highway 299) towards the Ash Street low water crossing.

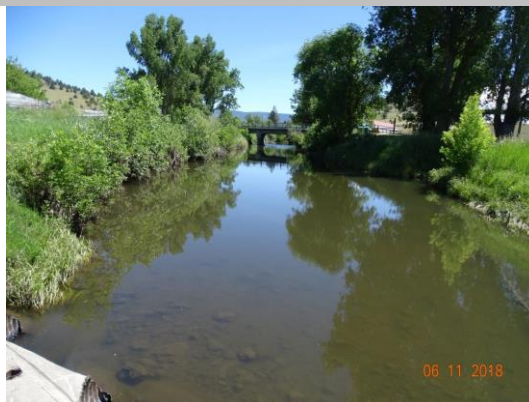
Photo 1 of 1 : CH_2018_NA0030_1_11_20180618_00009.jpg

Inspector Comments: The channel is clear of vegetation & obstructions.

View of the channel from Ash Street low water crossing.

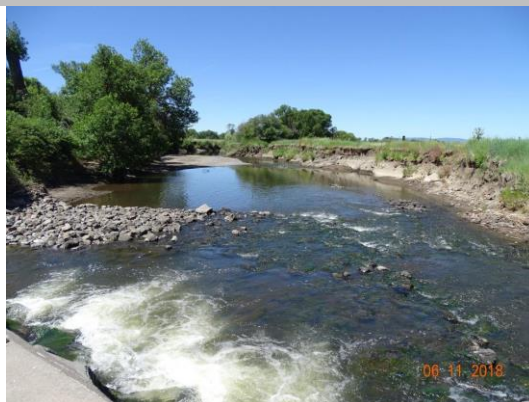
Photo 1 of 1 : CH_2018_NA0030_1_16_20180718_00013.jpg

Rating **	A	Issue No.	16	GPS Lat/Long
Issue Type +	Ma	Location *		41.197138 °
Category	Rivers, Channels & Designated Flood			-120.945271 °
Item	Vegetation & Obstructions			
DWR ID	DWR_NA0030_1_c _ 2012_16			
Action/Comments				
Inspector Comments: Minimal, scattered obstructions or vegetation. The flow is not impeded.

Vegetation well maintained or not impacting capacity.

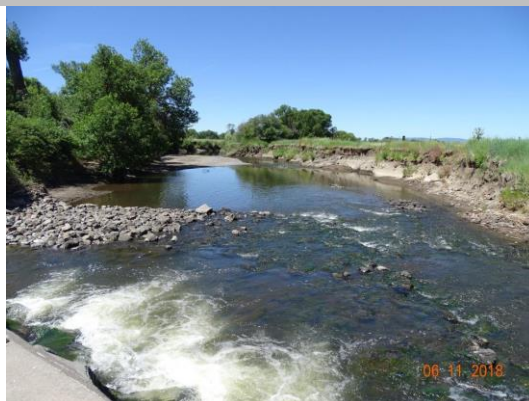
Photo 1 of 1 : CH_2018_NA0030_1_18_20180618_00010.jpg

Rating **	M	Issue No.	18	GPS Lat/Long
Issue Type +	Ma	Location *		41.197138 °
Category	Rivers, Channels & Designated Flood			-120.945271 °
Item	Erosion / Bank Caving			
DWR ID	DWR_NA0030_1_c _ 2012_18			
Action/Comments				
Inspector Comments: During low flows you can see the two gravel bars in channel and monitor erosion during high flows.

View of the gravel bars and moderate erosion on both banks.

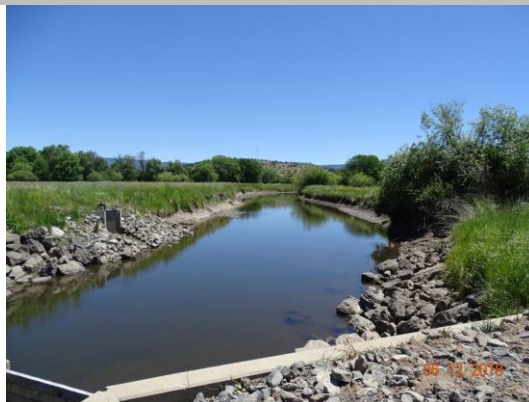
Photo 1 of 1 : CH_2018_NA0030_1_31_20180618_00011.jpg

Inspector Comments: The channel is clear of vegetation & obstructions.

View of the upstream side of the weir.

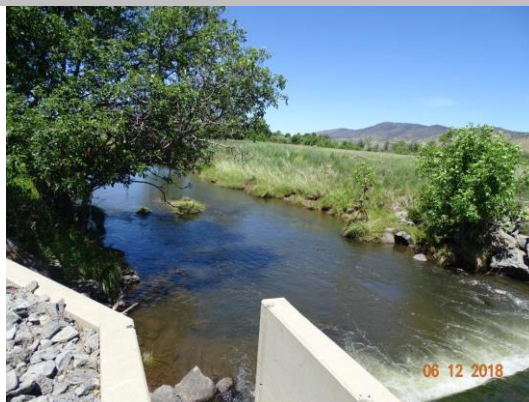
Photo 1 of 1 : CH_2018_NA0030_1_36_20180618_00012.jpg

Inspector Comments: The channel is clear of vegetation & obstructions.

View of the downstream side of the weir.

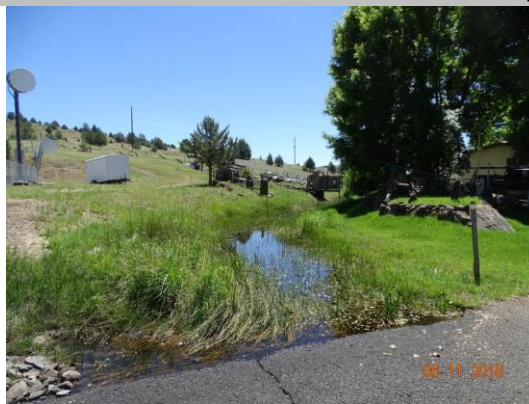
Photo 1 of 1 : CH_2018_NA0030_2_1_20180618_00005.jpg

Rating **	A	Issue No.	1	GPS Lat/Long
Issue Type +	Ma	Location *		41.195370 °
Category	Rivers, Channels & Designated Flood			-120.943190 °
Item	Vegetation & Obstructions			
DWR ID	DWR_NA0030_2_c _ 2012_1			
Action/Comments				
Inspector Comments: Remove all vegetation in channel before winter. Mike Williamson said they will remove the vegetation before winter.

View from Adin Street looking upstream at minimal vegetation in channel.

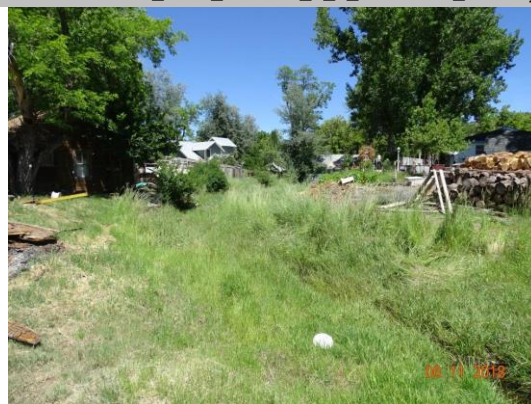
Photo 1 of 1 : CH_2018_NA0030_2_6_20180618_00006.jpg

View from Ash Street looking downstream at minimal vegetation in channel.

Inspector Comments: Remove all vegetation in channel before winter.

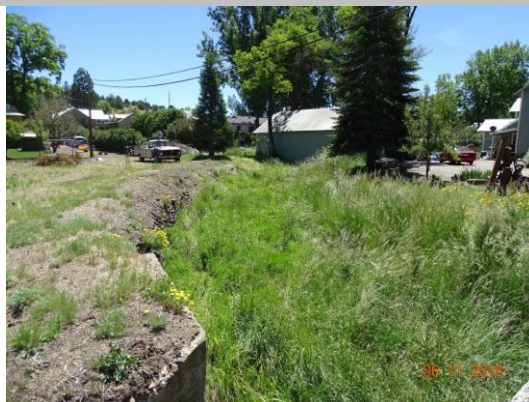
Photo 1 of 1 : CH_2018_NA0030_2_11_20180618_00007.jpg

View from Main Street looking upstream at minimal vegetation in channel.

Rating **	A	Issue No.	11	GPS Lat/Long
Issue Type +	Ma	Location *		41.196350 °
Category	Rivers, Channels & Designated Flood			-120.944250 °
Item	Vegetation & Obstructions			
DWR ID	DWR_NA0030_2_c_2012_11			
Action/Comments				
Inspector Comments: Remove all vegetation in channel before winter.

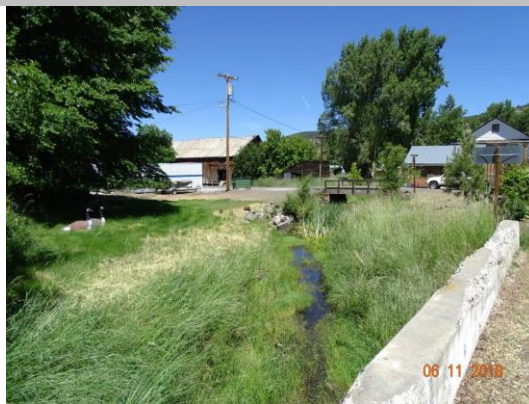
Photo 1 of 1 : CH_2018_NA0030_2_16_20180618_00008.jpg

Rating **	A	Issue No.	16	GPS Lat/Long
Issue Type +	Ma	Location *		41.196350 °
Category	Rivers, Channels & Designated Flood			-120.944250 °
Item	Vegetation & Obstructions			
DWR ID	DWR_NA0030_2_c_2012_16			
Action/Comments				
Inspector Comments: Remove all vegetation in channel before winter. The grass should be mowed before flood season.

View from Main Street looking downstream at minimal vegetation in channel.
